Immediately Dangerous to Life and Health

The Cost of Failing To Identify and Mitigate IDLH Hazards

Senior Management ViTS Meeting

Sept. 8, 2015

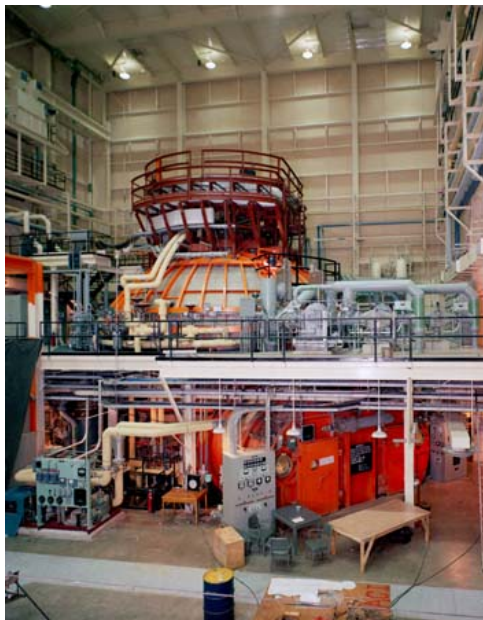
JSC Chamber B Type B Mishap, 2010

- **Event:** Chamber B is a human-rated thermal vacuum test facility. During maintenance activities inside, an electrical technician climbed a ladder in Chamber B to install a vacuum transducer. The technician “noticed something was not right” and started to descend the ladder, but briefly lost consciousness. The technician fell to the floor and sustained minor injuries.
- **Proximate cause:** The technician climbed unknowingly into an oxygen deficient atmosphere in the upper portion of the chamber.
- **Root causes:**
 - 1) Chamber entry requirements training was ineffective.
 - 2) There was no strict entry procedure required to enter or allow entry into the chamber.

3) The facility hazard analysis addressed hazards, but not all controls identified in the hazard analysis were enacted for operations. The analysis identified ventilation as a control, but did not specify when ventilation was needed. There was no procedure to provide ventilation before or during entry, or verification of safe atmosphere in breathing zones before entry.

JSC Building 32, Chamber B

- “There was no strict entry procedure required to enter or allow entry into the chamber.”
- The facility hazard analysis addressed hazards, but not all controls identified during the investigation were included...no procedure to implement ventilation before or during entry.”

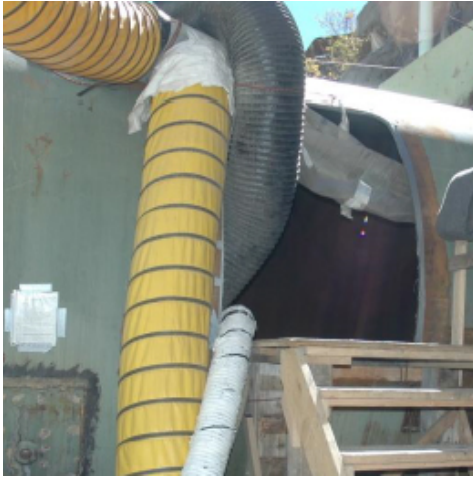
Xcel Energy Penstock Fire, 2007

- <https://nsc.nasa.gov/Resources/SFCS/vapor-trap>
- **Event:** Five industrial painters were killed while recoating a portion of tunnel in a remote mountainous area near an Xcel Energy hydroelectric station. The workers cleaned their equipment with a highly flammable solvent, which filled the tunnel with flammable vapor.

- **Proximate cause:** The vapor ignited and the resulting explosion blocked five painters from their only egress point by a wall of fire. Despite lengthy rescue attempts, all five painters were asphyxiated as smoke slowly filled the tunnel.

- **Underlying issues:**
 1. The tunnel's 4,000-foot length made it an exception to OSHA confined space classification.
 2. While Xcel and the recoating contractor assessed the tunnel as a confined space anyway, neither company treated it as such during actual work. Air monitoring was done only at the entrance, not 1,450 feet away at the actual work area on the day of the fire.

Xcel Energy Penstock

- “Managers...failed to identify serious safety hazards involving use of flammable liquids inside a confined space.”

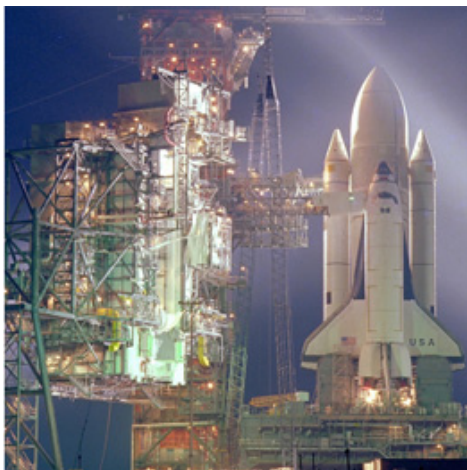
STS-1 Pre-Launch Mishap, 1981

- <https://nsc.nasa.gov/Resources/SFCS/tough-transitions>
- **Event:** As ground crews worked diligently to prepare for the launch, a group of technicians collapsed inside Columbia's nitrogen-filled aft compartment after a countdown demonstration test on March 19. Nitrogen exposure would claim three of the technicians' lives.
- **Proximate Cause:** Test directors and other involved personnel lacked formal communication about the nitrogen purge extension and dropped access controls prematurely.

1. Nitrogen purge test procedures were unclear and incomplete; launch pad closure/opening criteria were not included. No provision for extending the test was included. Impact of an extension on other collateral operations were not considered.
2. Over 500 late-schedule deviations besides the nitrogen purge extension prevented integrated operations impact discussion and planning.
3. Ground processing teams worked to accomplish as many tasks as possible without coordinating with the Firing Room staff who were responsible for controlling integrated operations.

STS-1

- “The test procedure in progress did not contain adequate steps for clearing the vehicle/pad complex for hazardous operations or completely reopening the vehicle/pad complex for resumption of scheduled normal work.”
- “There was no formal coordination with any of the element test conductors by the NASA Test Director (NTD) immediately prior to opening the pad, although all test conductors had been involved in earlier discussion on the subject.”
